TECHNICAL BULLETIN No. 652

FEBRUARY 1939

FLOW OF WATER IN IRRIGATION AND SIMILAR CANALS

FRED C. SCOBAY
Senior Irrigation Engineer
Division of Irrigation
Bureau of Agricultural Engineering

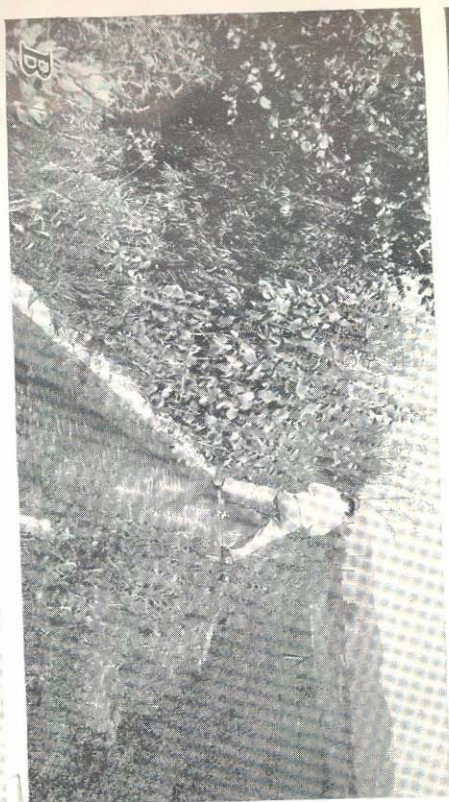
A, North canal, Bend, Oreg. (Nos. 123 to 128, inclusive; downstream from station 5.) B, Small ditch near Whittier, Calif. (No. 130; view upstream from station 2.) Clear water filling concrete section. C, Lower canal, Riverside, Calif. (No. 131; upstream from station 2.) A cement-plaster lining. Note weeds in broken places.

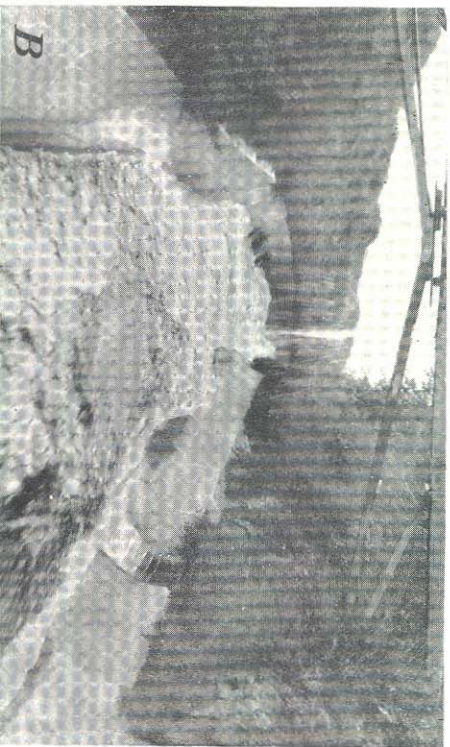
4. Lower canal, Lindsay-Straffmore irrigation district, California. (No. 169.) Concrete lining bet. as shot from a gun. Note characteristic uneven water line and concrete surface. Contrast this lining with later shot-concrete linings as made in Texas (Pl. 2, A). B. Sulphur Creek wasteway, Washington. Note long standing weils. (See Nos. 435 to 450.) C. Maverick County Water Control and Improvement District No. 1, Texas. Excavated in thin strata (see rocks in foreground), the bottom was smooth but the sides of this canal were exceedingly rough. To increase the capacity the sides were lined with redwood planks spaced to allow water to pass freely and not build up an unbalanced static head on either side of the lining. In right foreground the vertical studding is shown anchored to the bed.

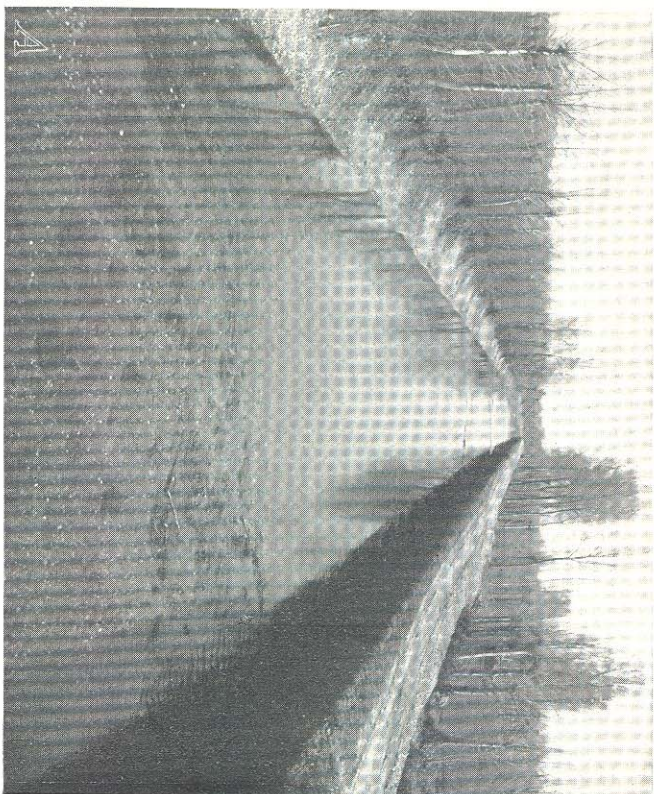
4. Canale Fossa di Pozzolo, Italy. (No. 401-2, viewed upstream.) An old canal with typical elliptical bed. The side on the left, approaching the vertical, is characteristic of old canals such as this in the United States. The other bank is a vertical wall. Note the rocky bed and the moss patches in the foreground. Photograph by courtesy of Marco Visentini who reported experiments on this canal. B. Minor-flooding main canal, Idaho. Unusual construction. The dry-laid rock walls were backfilled with gravel and earth, through a badly fissured rock cut. Photograph from Bureau of Reclamation.

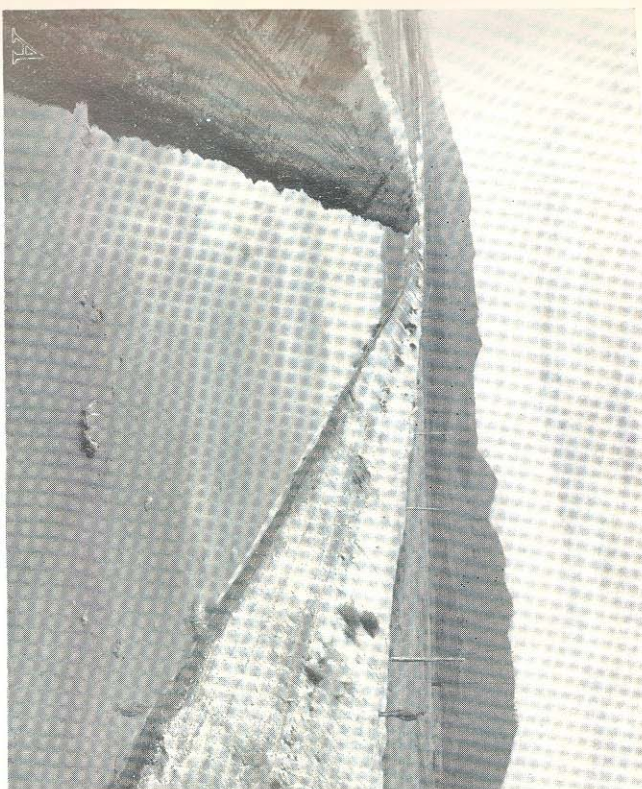
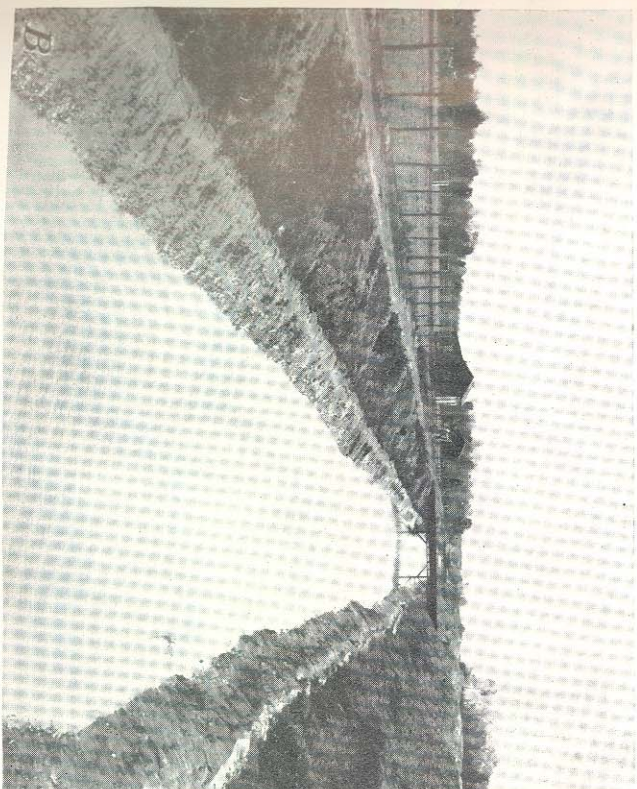
4. A new canal conveying clear water. The original trapezoidal shape beginning to round off at the corners to form the eventual ellipse (with nearly vertical sides if grasses root along the bank). B. A new canal or apparently cleaned, conveying silty waters. The mud berms develop at the sides and crowd in until an more than a tenth of a foot or so has deposited on the bottom. Sometimes these berms are 2 feet or more wide while not 3 feet per second becomes protected with a slick coat that will withstand velocities of 5 to 6 feet per second. Photographs from Bureau of Reclamation.

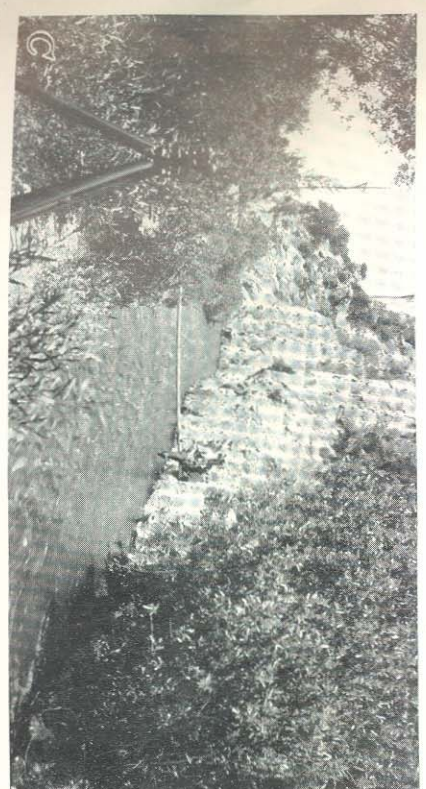
A, Logan, Hyle Park, and Smithfield canal, Utah. (No. 398; downstream near lower end of reach.) B, Lower canal, Riverside, Calif. (No. 405; upstream from station 6.) Note plank lining. C, Logan, Hyle Park, and Smithfield canal, Utah. (No. 408; downstream past meter station.) Note engineer's level in foreground, left.

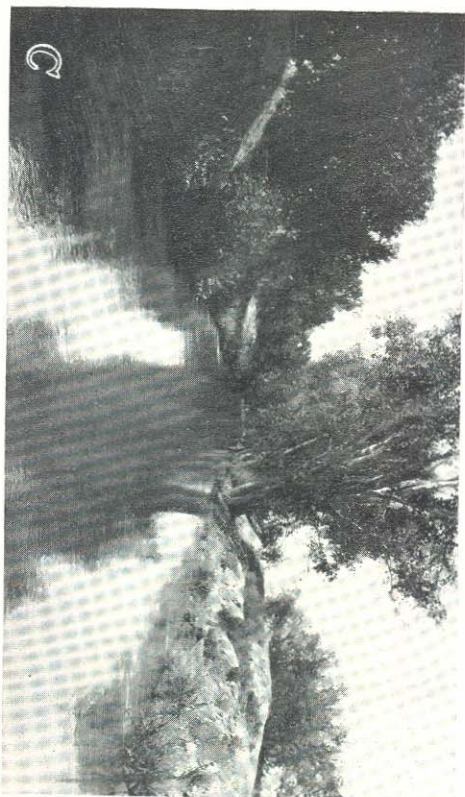
A, Orr ditch, Reno, Nev. (No. 434; upstream from station 1 plus 30. Station 0 is at bridge shown.) B, Farmer's (Gr-Stato) canal, Nebraska (No. 191; portable floating car and meter station.) C, Maricopa canal, near Phoenix, Ariz. (No. 194; downstream from station 0.)

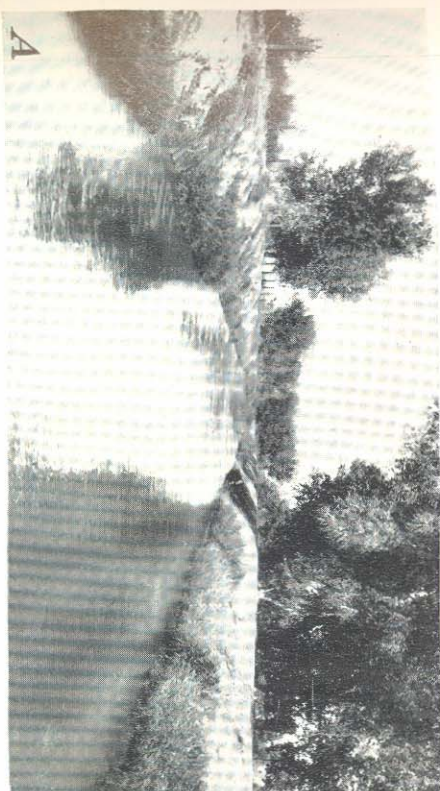
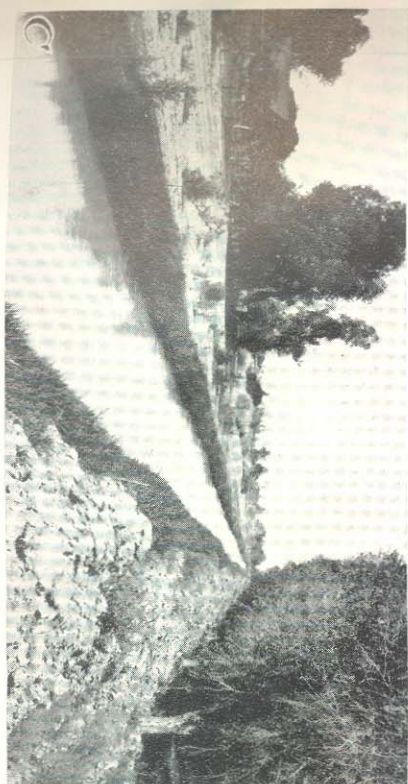
A, Grand canal, near Phoenix, Ariz. (No. 215; upstream from station 10.) B, Lateral 7, Turlock irrigation district, California. (No. 239; downstream from station 0.) Note general high-water line. C, Birch canal, Imperial Valley, Calif. (No. 250; downstream from meter station 6.)

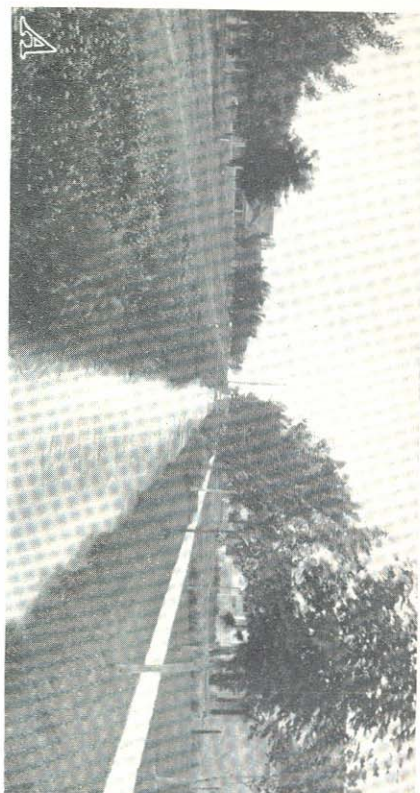
A, Lateral, South Side Twin Falls canal, Idaho. (No. 305; downstream from station 0.) B, Main branch, Turlock irrigation district, California. (No. 303; upstream from station 8.) C, Fullerton ditch, California. (No. 307; upstream from station 5.)

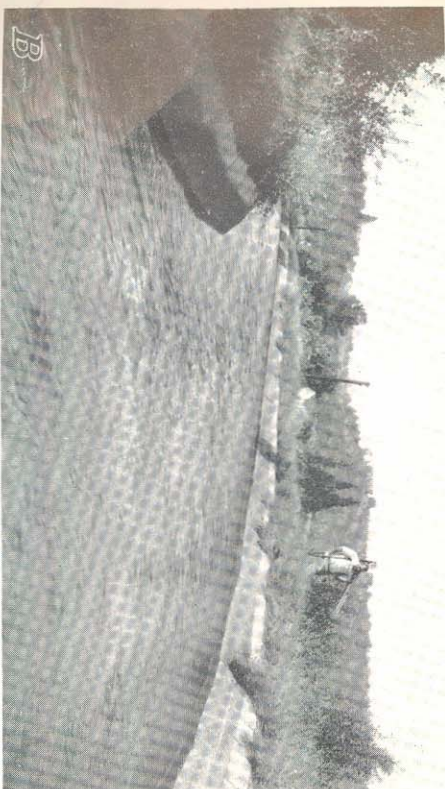
A, Drum canal, Pacific Gas & Electric Co., California. (No. 426.) Lower bank lined with concrete "plank" pieces and piled where needed to prevent erosion. B, South canal, near Auburn, Calif. (No. 98; downstream from about station 7 plus 50.) Many sharp bends. Note highest velocity on inside of curve. Water on outside boils up and is uncertain in direction. C, Deschutes municipal district, near Bend, Oreg. (No. 425; downstream from station 2.) Masonry walls and concrete floor.

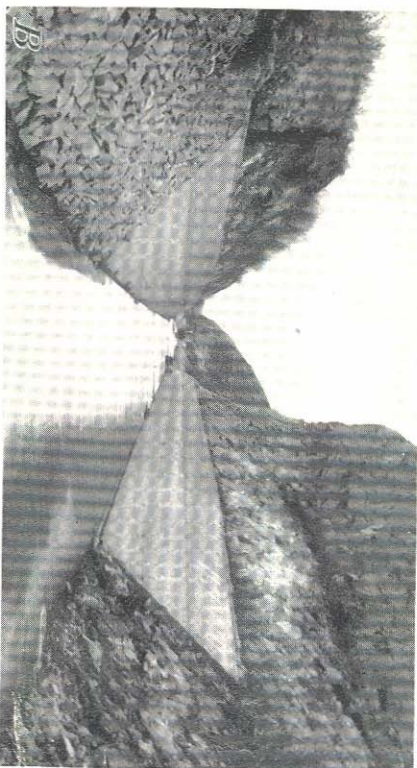
A. Reno ditch, Nevada. (No. 382 downstream from station 0) B. The banks below a concrete section should be protected with riprap while the velocity is being reduced to that permissible in the earth section. Bureau of Reclamation photograph. C. Nogales floodway, near international boundary between Arizona and Sonora. The Mexican mason is very adept at this masonry. Sometimes such a wall is shot with concrete and broomed or roweled to a smoother finish. Photograph by engineers of the United States section, International Boundary Commission.

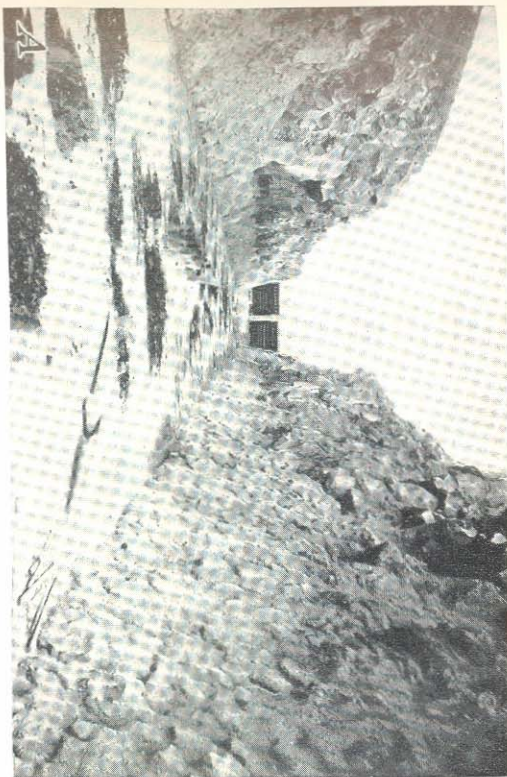
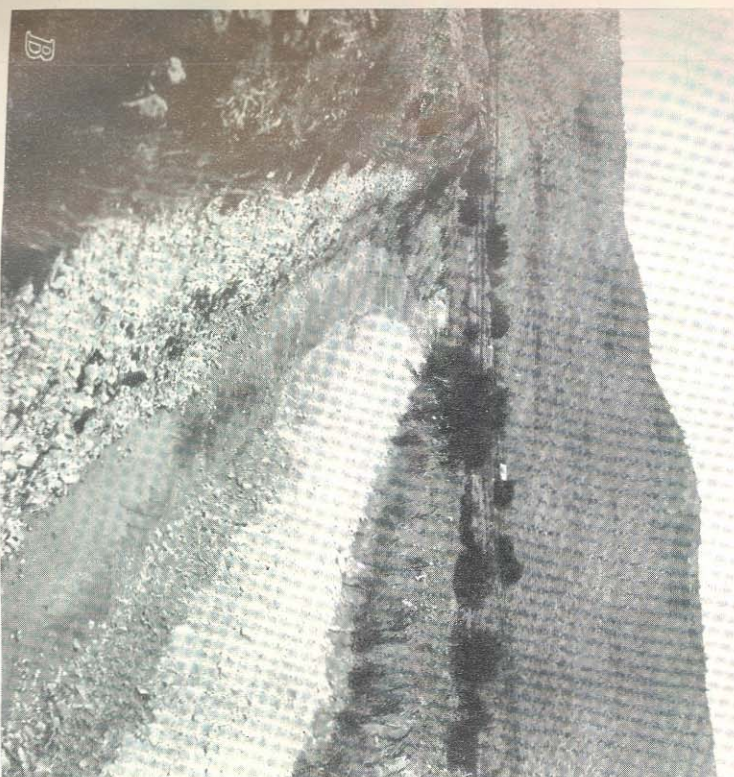
A. A very rough and porous cut in lava rock is made smooth on the bottom by a concrete lining while the sides are made watertight and materially smoother than before, with shot concrete. A good place to use Horton's formula for canal section with different bed and side characteristics. Bureau of Reclamation photograph. B. Cañalpo canal, Braden Copper Co., Chile. (Nos. 349 to 370 inclusive) Cobblestones are more in evidence on this run than on the other runs in western United States that develop a cobble from the bed with a skip and hoist. The company showed large areas of men removing the loose boulders of Braden Copper Co. Note that values of n above 0.480 predominate. View by courtesy
